# Manhole Inspection Summary

Manhole # S37EE\_069MH

Insp Date: **3/28/07 10:57 AM**

**Location** Address: **620 BIDDLE ST**

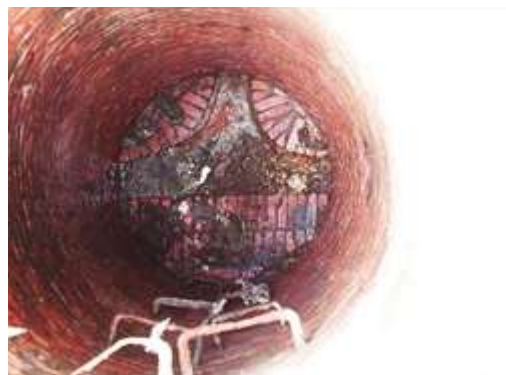
Top View

Corroded steps. Evidence of surcharge - Bench debris. Channel debris.

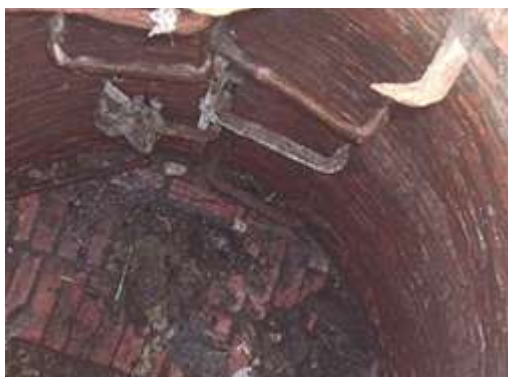
Defect

Corbel and Barrel infiltration. Evidence of surcharge - Bench debris. Corroded and missing steps.

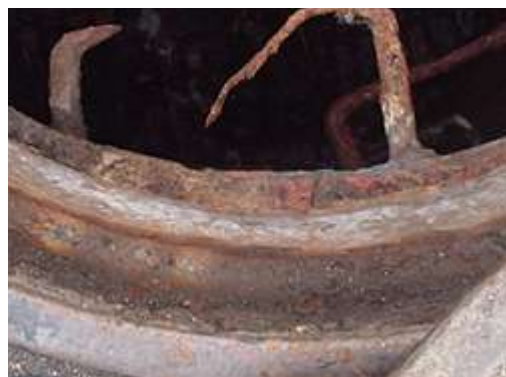
Defect

Frame offset.

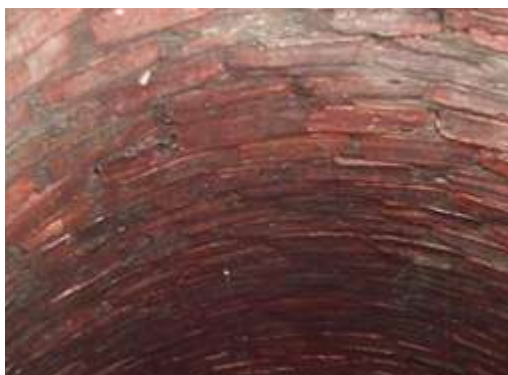
Defect

Adjustment and Corbel deterioration and infiltration.

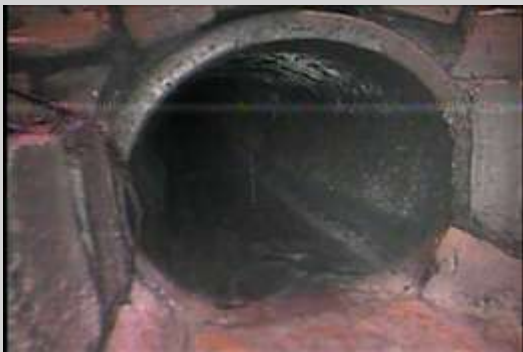
### 8 in. Circular Gravity Sewer Pipe Out @ 12 O'Clock

Invert Depth: **10.93** (ft.) Flow Characteristics: **Slow**

Deposits: ☒ None ☐ **Mud** ☐ Sludge ☐ **Debris** ☐ Grease

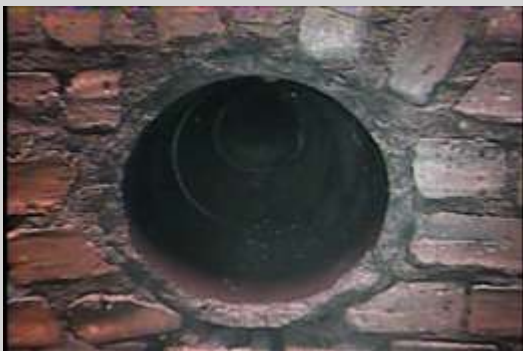
### 8 in. Circular Gravity Sewer Pipe In @ 3 O'Clock

Invert Depth: **6.24** (ft.) Flow Characteristics: **None**

Deposits: ☐ None ☒ **Mud** ☐ Sludge ☒ **Debris** ☐ Grease

Silt Depth: **5** (in.) Deposits Extent: **Heavy**

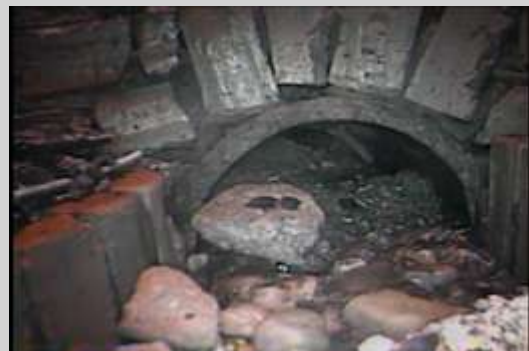
### Drop In @ 3 O'Clock

Drop: **Outside** Rod and Bar

Angled: **Yes** Reading: **9.27** (ft.)

Inv Depth: **10.27** (ft.)

Drop Condition: **Open**

Connects To: **Dead End**

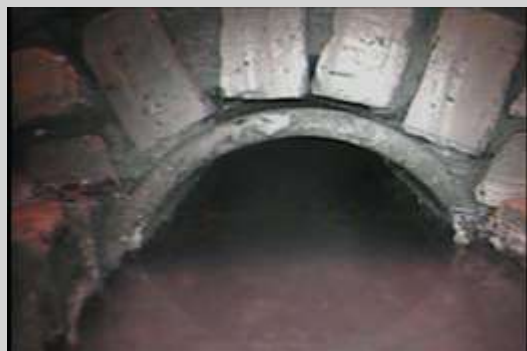
Pipe In @ 9 O'Clock

Invert Depth: **10.89** (ft.) Flow Characteristics: **Slow**

Deposits: ☐ None ☒ **Mud** ☐ Sludge ☒ **Debris** ☐ Grease

Silt Depth: **2** (in.)

Deposits Extent: **Light**
